Minus One

By PR1(AW) Lee Reichard

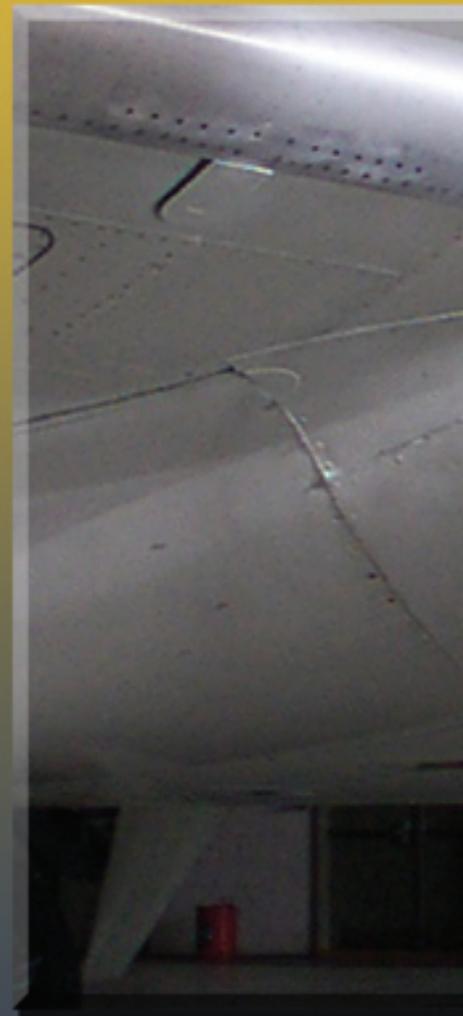
Kidney Panel

The pilots heard a loud bang, and the cabin pressure fluctuated. The aircraft commander called home station and returned to the field. After landing, quality-assurance reps looked over the airplane and found a “kidney panel” was missing. That panel is located on the belly, just forward of the starboard main-landing gear.

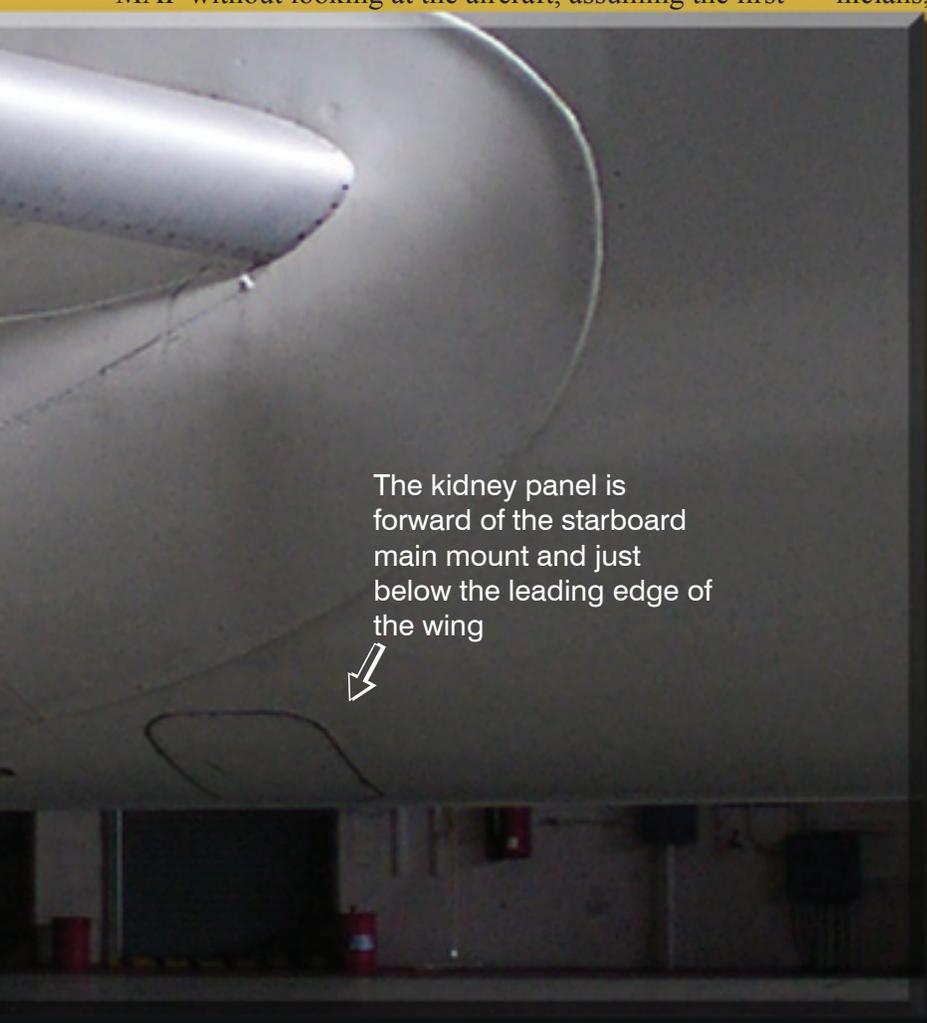
The kidney panel is forward of the starboard main mount and just below the leading edge of the wing
