Is It Supposed to Bend That Way?

By Lt. Michael Crisp

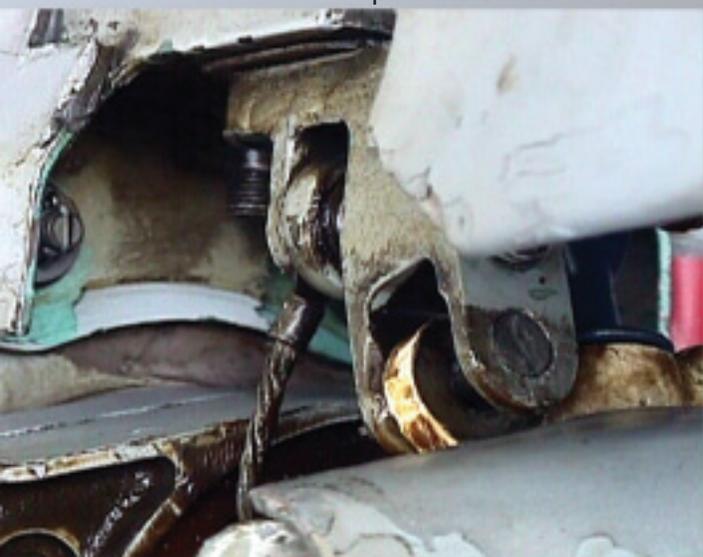
The threaded rods, ends on the outer-wing panels are supposed to have washers nuts and cotter pins installed.

A post-flight inspection found the threaded rods on the right, outer-wing were missing all washers, nuts and cotter pins. The rods had moved approximately two inches forward of correct position, enabling the outer wing to fold up a little.

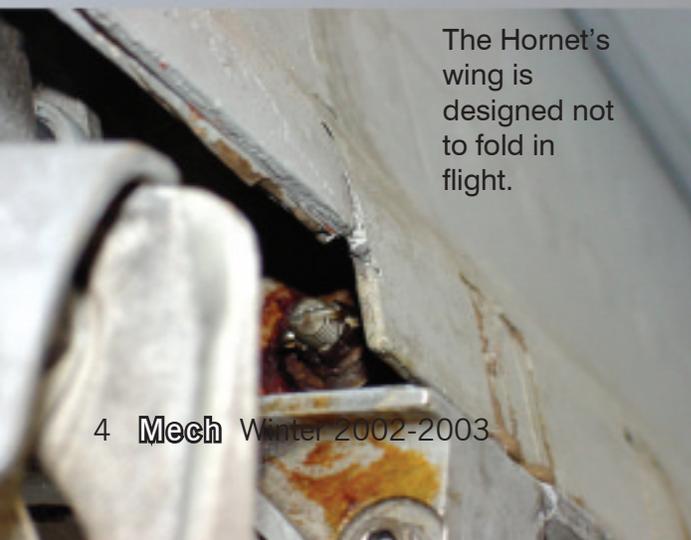
The Hornet’s wing is designed not to fold in flight.

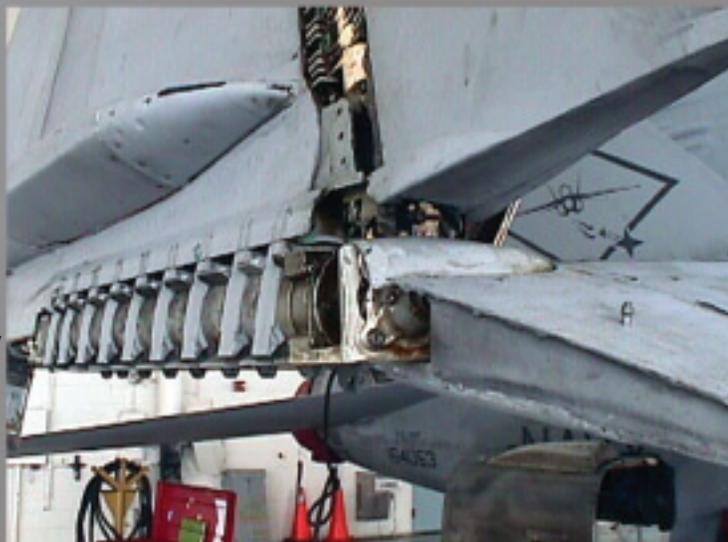
Without the necessary hardware, the wing inadvertently could move.
