Old Habits, New

By AME1(AW) Kurt Ervin

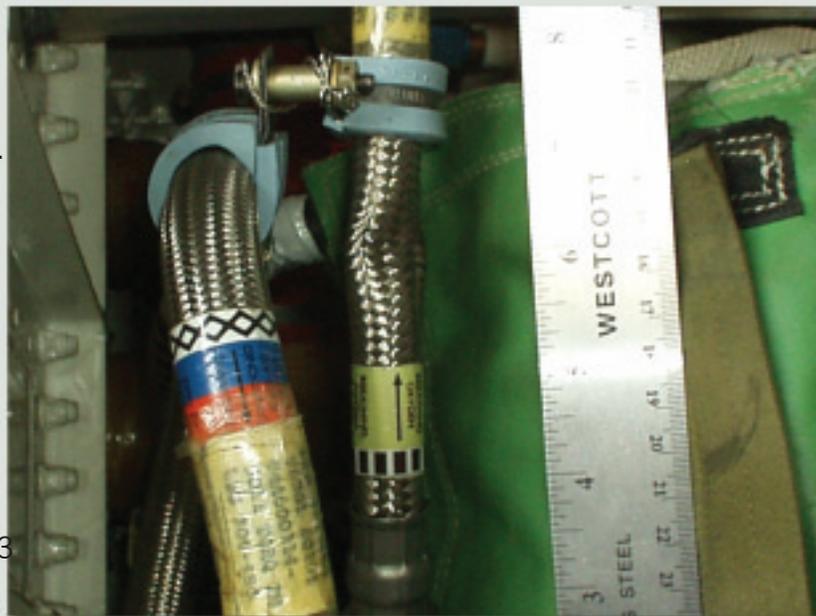
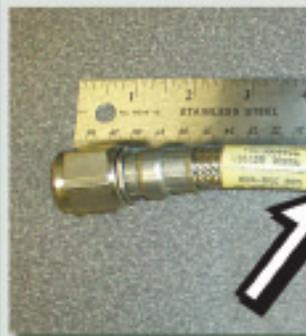
After removing the concentrator, an AME2 showed me an OBOGS line he had removed. We could see it almost completely was closed off, blocking the flow of oxygen. We quickly recognized this crimp could be the source of the problem. A closer look revealed the hose's exterior metal braiding had separated from the plastic tube inside, and this defect had hidden the true condition of the hose.

To remove the OBOGS concentrator, Sailors often bend the OBOGS line (left of the ruler) out of the way.

The bent line can restrict oxygen flow.

We turned in the damaged lines for an EI. That investigation revealed the crimped hose did cause a little backpressure within the OBOGS concentrator. As a result, a significant amount of oxygen was ported out the concentrator's nitrogen check valves, instead of going to the pilot. This reduced amount of oxygen did not impair a pilot's performance,

until the aircraft reached very high altitudes. A final piece of this puzzle could have turned the situation lethal: The OBOGS oxygen monitor detects only the oxygen concentration within the concentrator, which means an "OBOGS DEGD" caution would not light up because the level in the concentrator was unaffected. An oxygen monitor does not exist downstream, so the pilot never will get a warning of this lethal defect.

We learned to stop treating OBOGS lines like LOX lines. Remove the positioning clamp and move the product line to the side, taking care not to damage it. Hypoxia has killed before; this find may keep it from killing again. 🦋

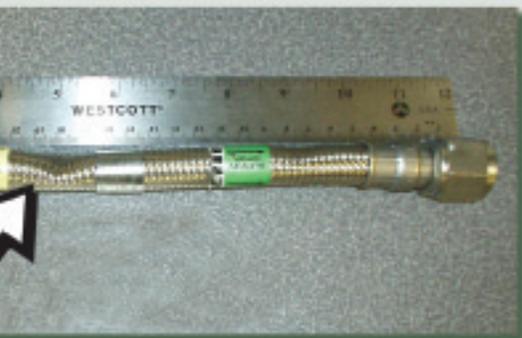
A rigid, plastic, inner sleeve is inside this braided line and does not regain its shape when bent.
