# GROUND WARRIOR

The Marine Corps' Ground Safety Magazine

Summer 1999

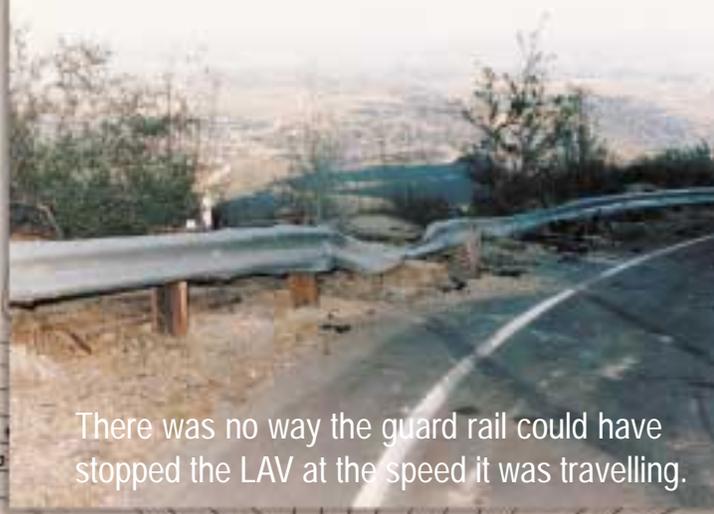
LAV crashes through guard rail

There was no way the guard rail could have stopped the LAV at the speed it was travelling.

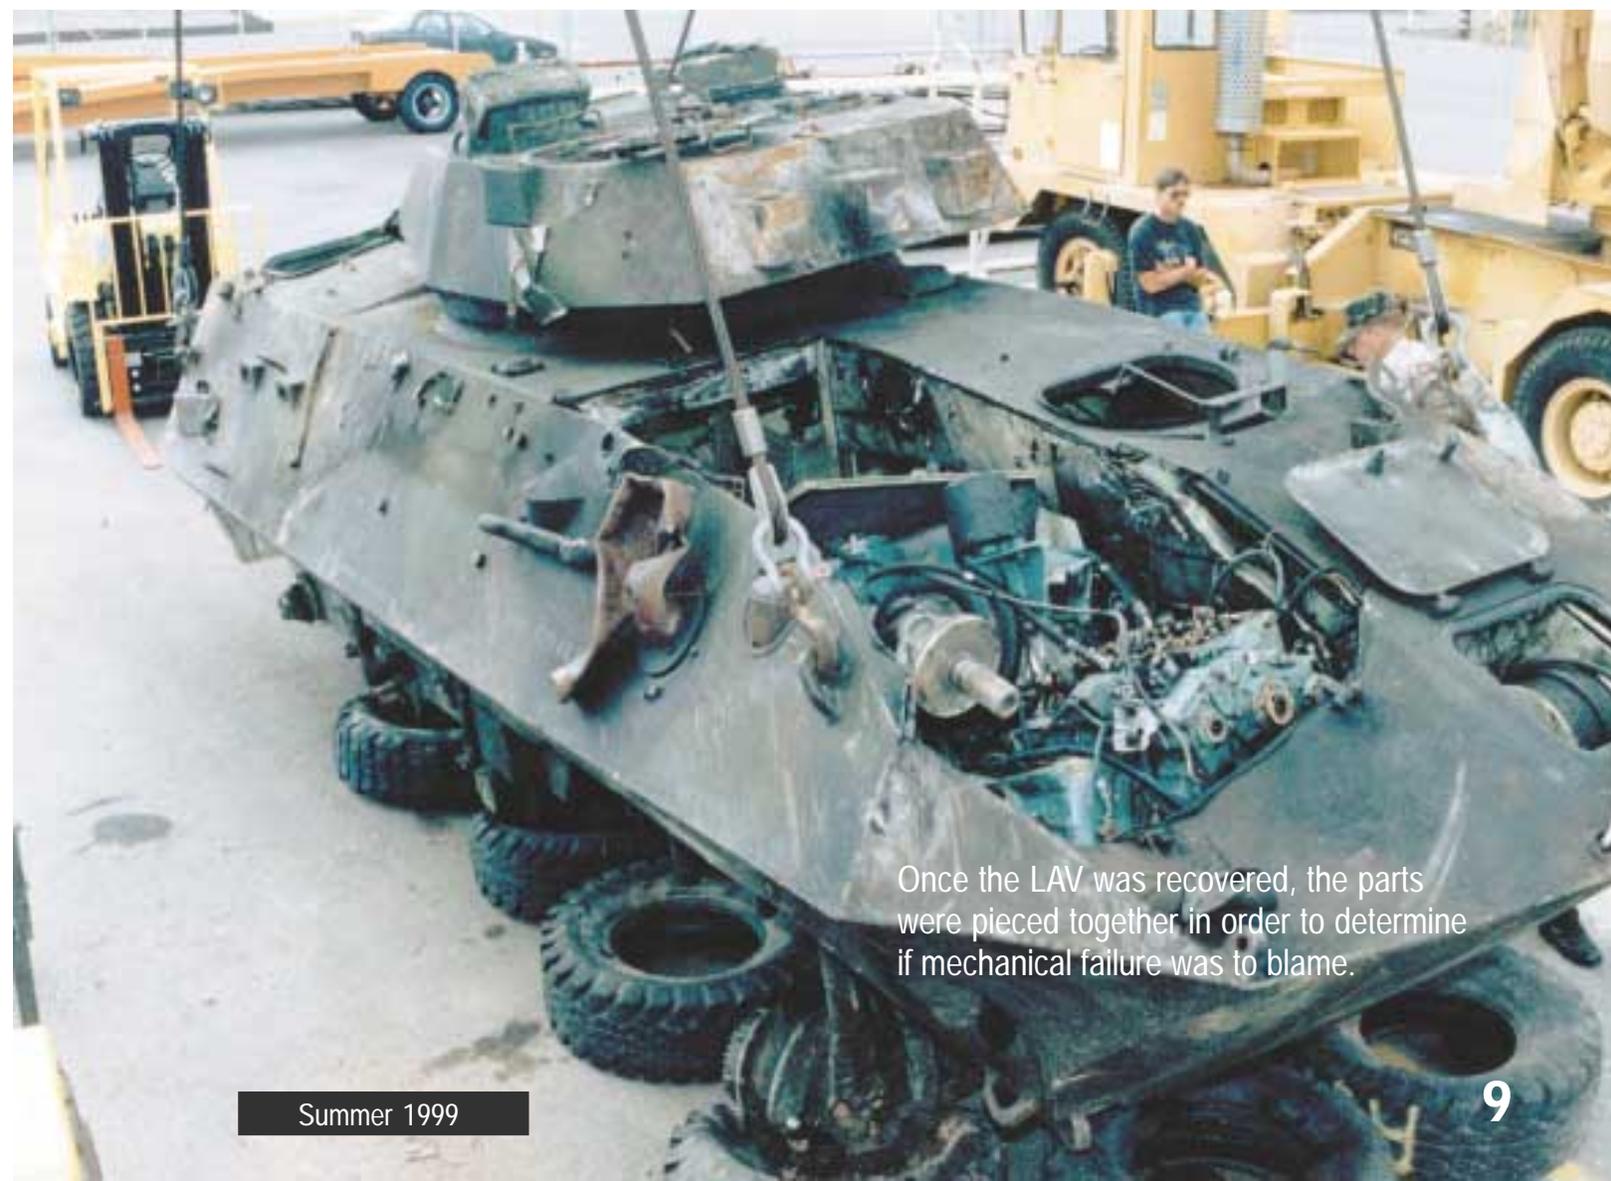
Once the LAV was recovered, the parts were pieced together in order to determine if mechanical failure was to blame.

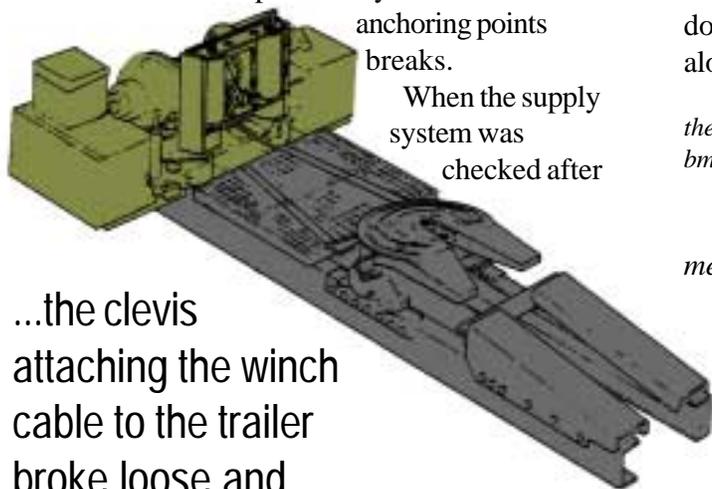
After the mishap, inspectors found that the clevis and clevis-retaining pin were bent so badly that when the winch was engaged, the bent retaining pin came under too much stress. The retaining-pin cap broke, and the retaining pin worked loose.

...the clevis attaching the winch cable to the trailer broke loose and whipped around.

*WSEM Alert A0022-98 addresses the replacement clevis pins. – Ed.*

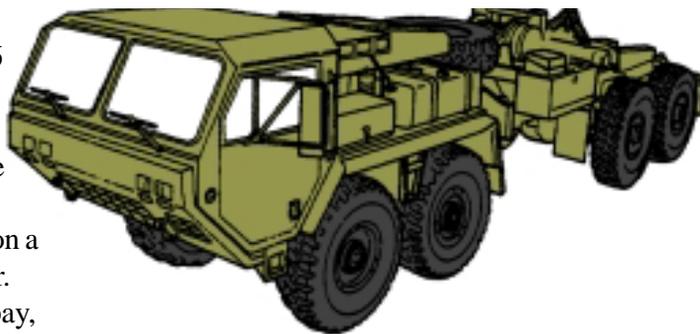
the mishap, no clevis pins were available. A quick inspection of Mk-16 and Mk-16A1 winches at the MCB revealed many pins with stress marks, bent shafts, and corroded or deformed retaining-pin caps, as well as non-standard safety pins. The winch comes with an incorrect clevis pin. The correct pin part number is 1517020W CAGE 45152. The correct quick-release pin part number is 2036040 CAGE 45152. To accomplish their mission, Marines were making do with non-standard parts or leaving damaged pins in place.

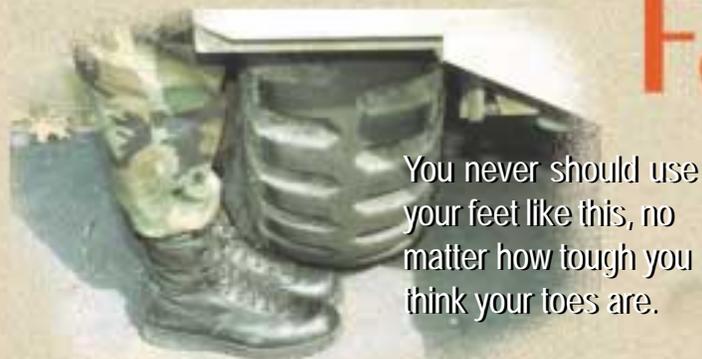
You never should use your feet like this, no matter how tough you think your toes are.

The Marine placed both feet against the block of wood to force the tires to get a better grip. His efforts were successful. The only problem was that the tires remained seized. The forklift driver, unaware of the hazard developing, continued to back up. This forced the block of wood, still securely held by the tires of the trailer, over both of the Marine’s feet.

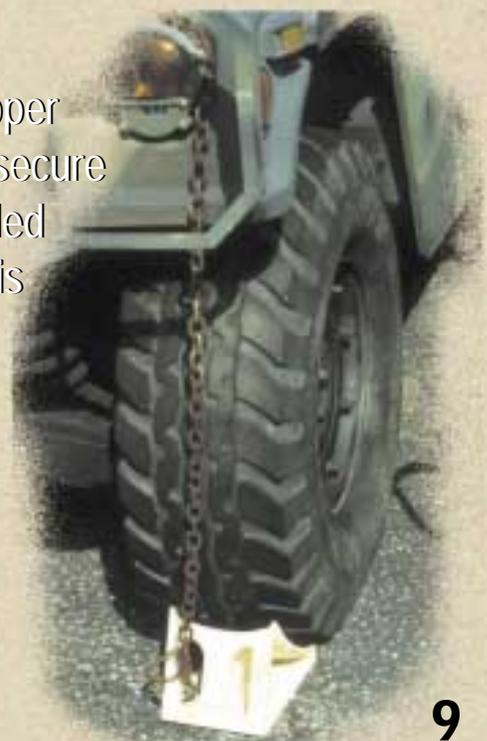
The proper way to secure a wheeled vehicle is with a chock.

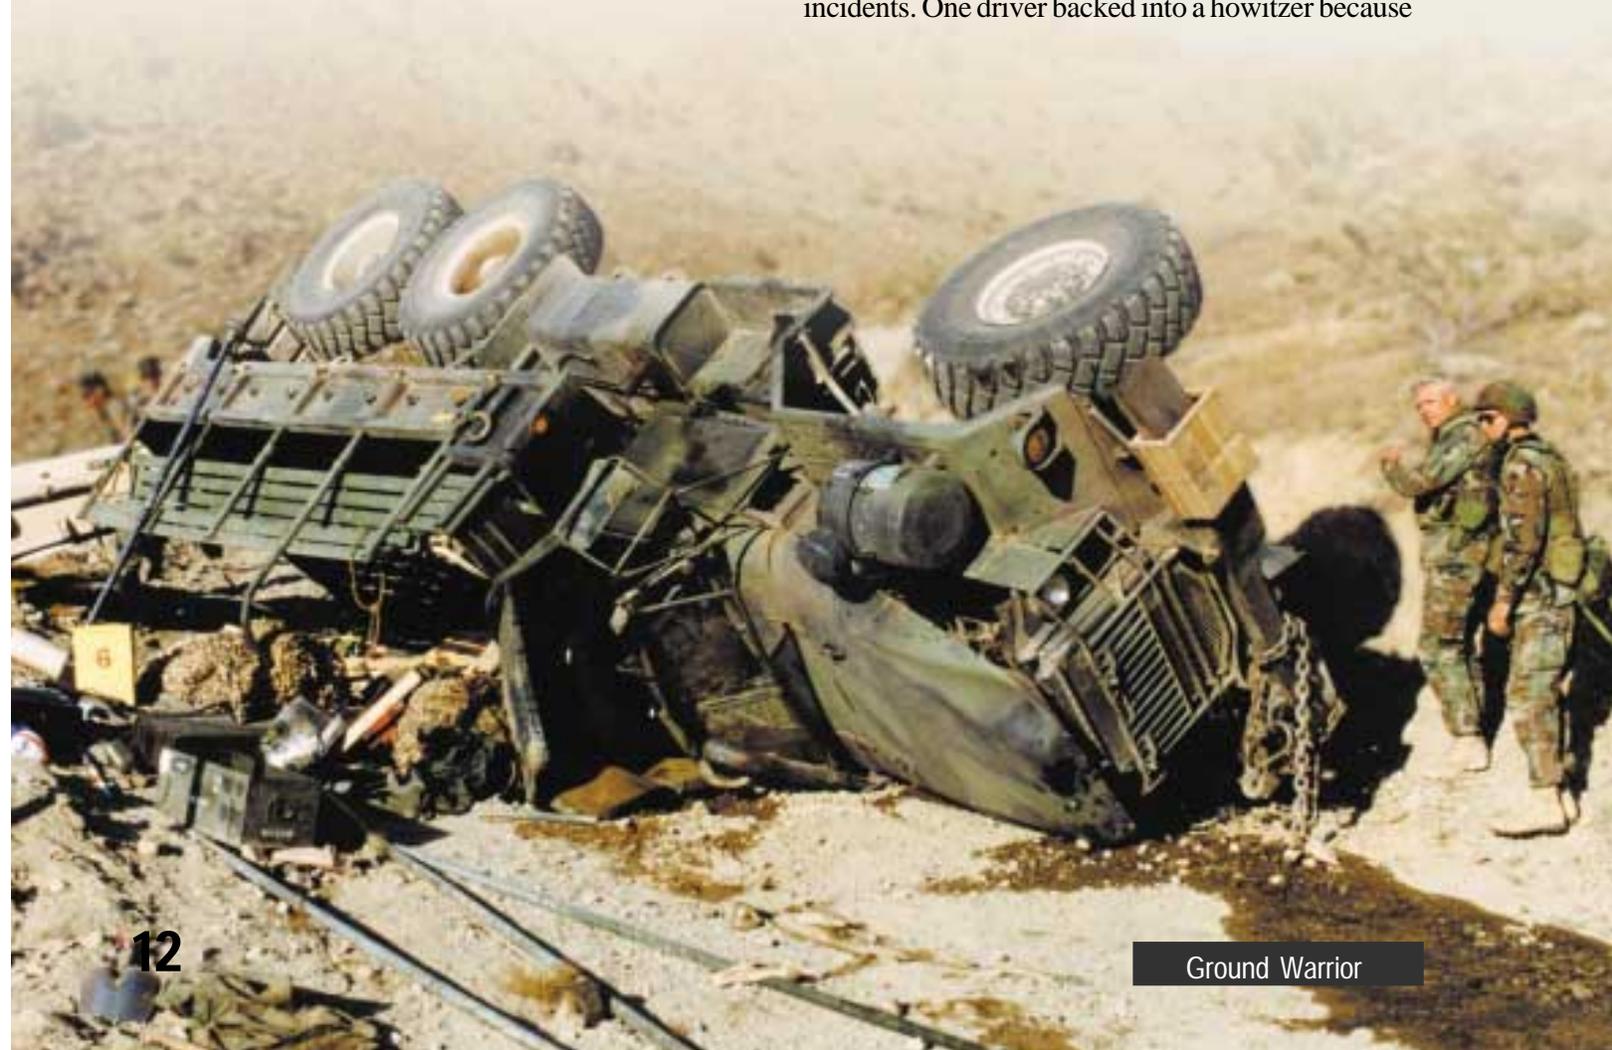
The howitzer, still attached to the 5-ton, hangs over the edge of the road. The speed of the 5-ton made the weapon bounce and whip over, pulling the truck with it.

- All six brake drums were out of round with hot spots.
- The left-front and the right-rear wheel cylinders were leaking.
- All the brake shoes and hardware needed cleaning.
- All the brake shoes were badly out of adjustment.
- The right-front and right-rear brake shoes were packed with mud.

The brake pedal went all the way to the floor board when the engineer pressed it the first time. The parking brake didn't work, and the parking-brake shoes were cracked and worn.

Why didn't maintenance fix the problem right the first time? The mechanics, after seeing the same vehicle several times for repeated brake problems should have investigated further and done a complete overhaul of the braking system. Some fault also lies with the battalion for accepting a 5-ton with inadequate repairs.

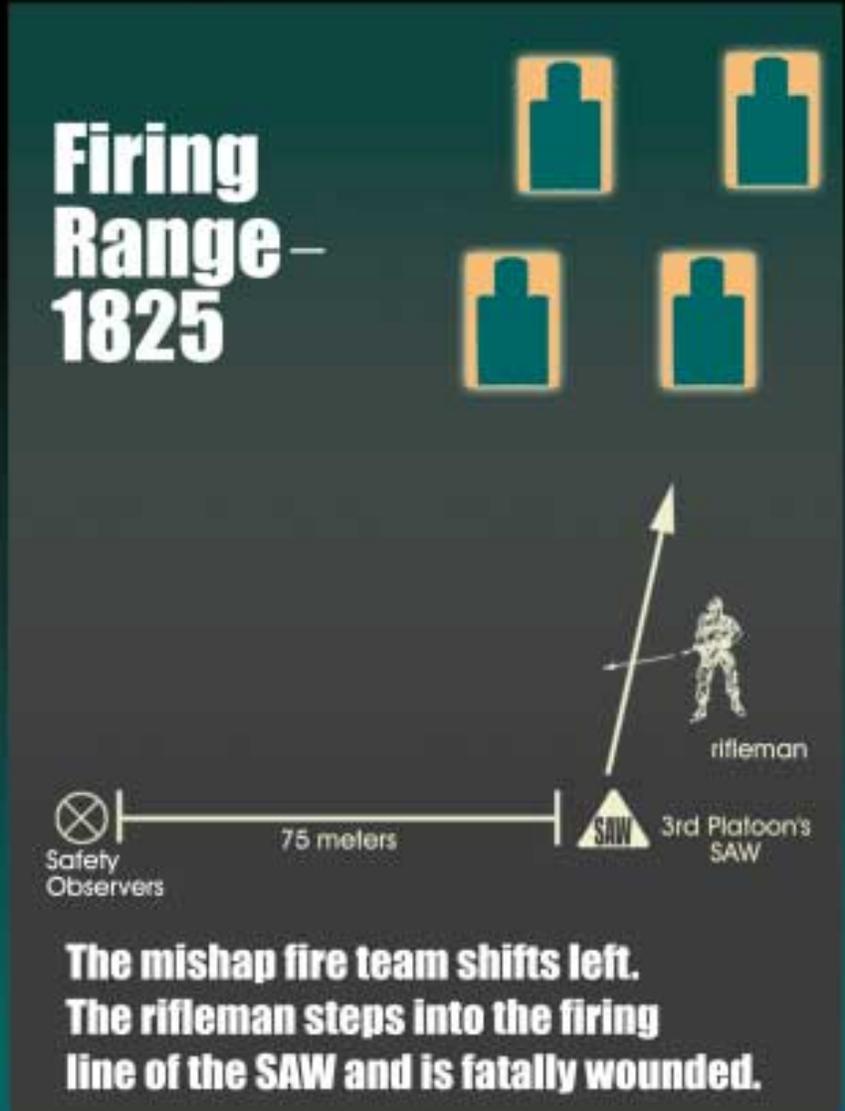
## Firing Range—1825

The mishap fire team shifts left.  
The rifleman steps into the firing  
line of the SAW and is fatally wounded.

Then disaster struck. One of the fire-team leaders from the third platoon gave the order to shift left. The fire-team SAW gunner was having problems with his weapon and didn't hear the order. At first, he had to pull the charging handle to the rear three times so he could start firing again. But one of the other riflemen from this fire team had acted immediately upon hearing the command. For some reason—whether the SAW was not firing or he couldn't see it—the

- The range officer in charge (ROIC) was uncertified.
- The safety observers assigned to the third squad were not briefed properly or supervised. They positioned themselves behind first squad, 75 meters from third squad. They should have been right behind third squad, in a position to immediately stop any unsafe acts.
- The M249 SAW gunner was not current with the weapon. His last hands-on training was eight months before this drill. He had been assigned to the SAW shortly before the exercise.
- No request to conduct a live-fire maneuver was submitted as required by the base range-safety regulations.
- Battalion officers did not review and approve the training plan. They also did not review the assignment of the ROIC and the range-safety officer.

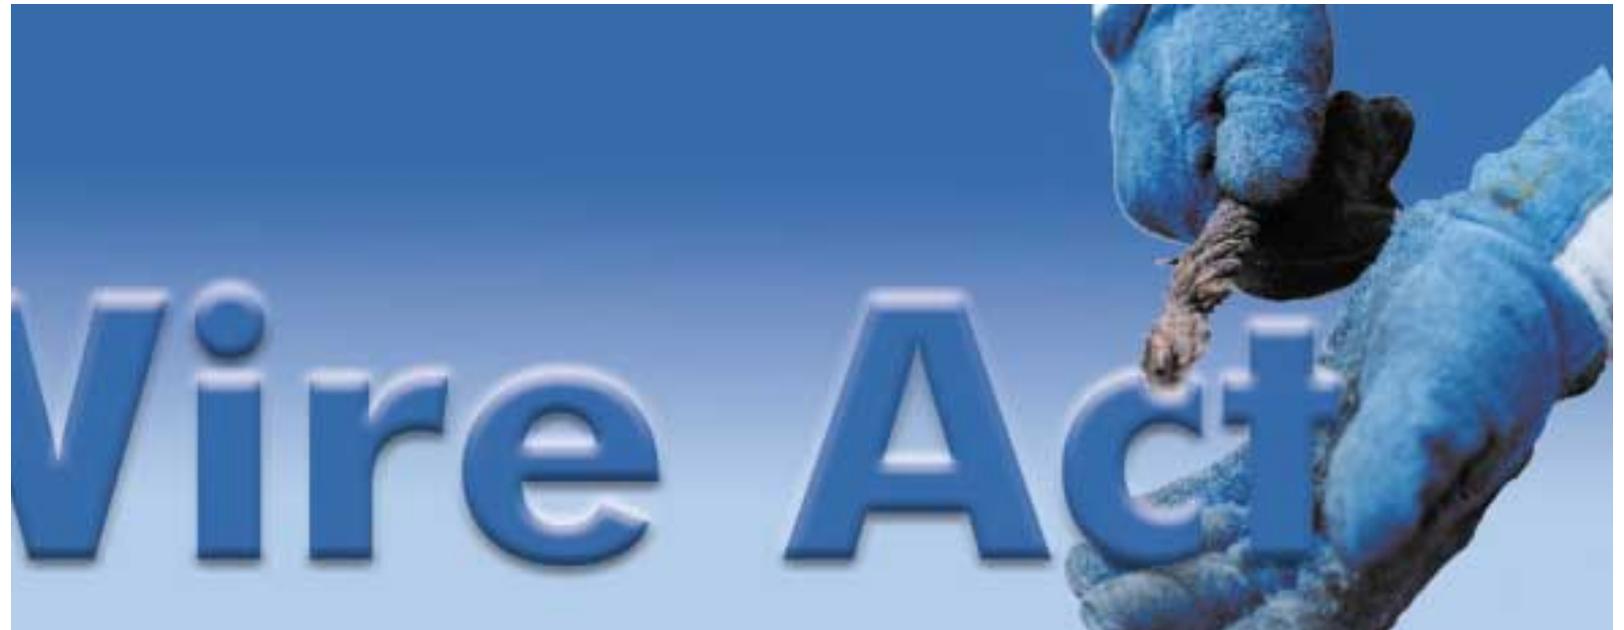
2. Lack of regularly scheduled inspection and maintenance. The wire rope was worn and frayed throughout its length. The safety line was rusted inside and out, and wires within each strand were broken. A technical manual (TM 5-725) outlines basic lubricating, cleaning, and inspecting wire rope, but it is up to the unit responsible to establish procedures defining who was supposed to maintain the rope and when they were supposed to do it. In this case, the unit hadn't.

3. Create a detailed SOP. The SOP then in effect said that an instructor was supposed to check the training apparatus for structural defects

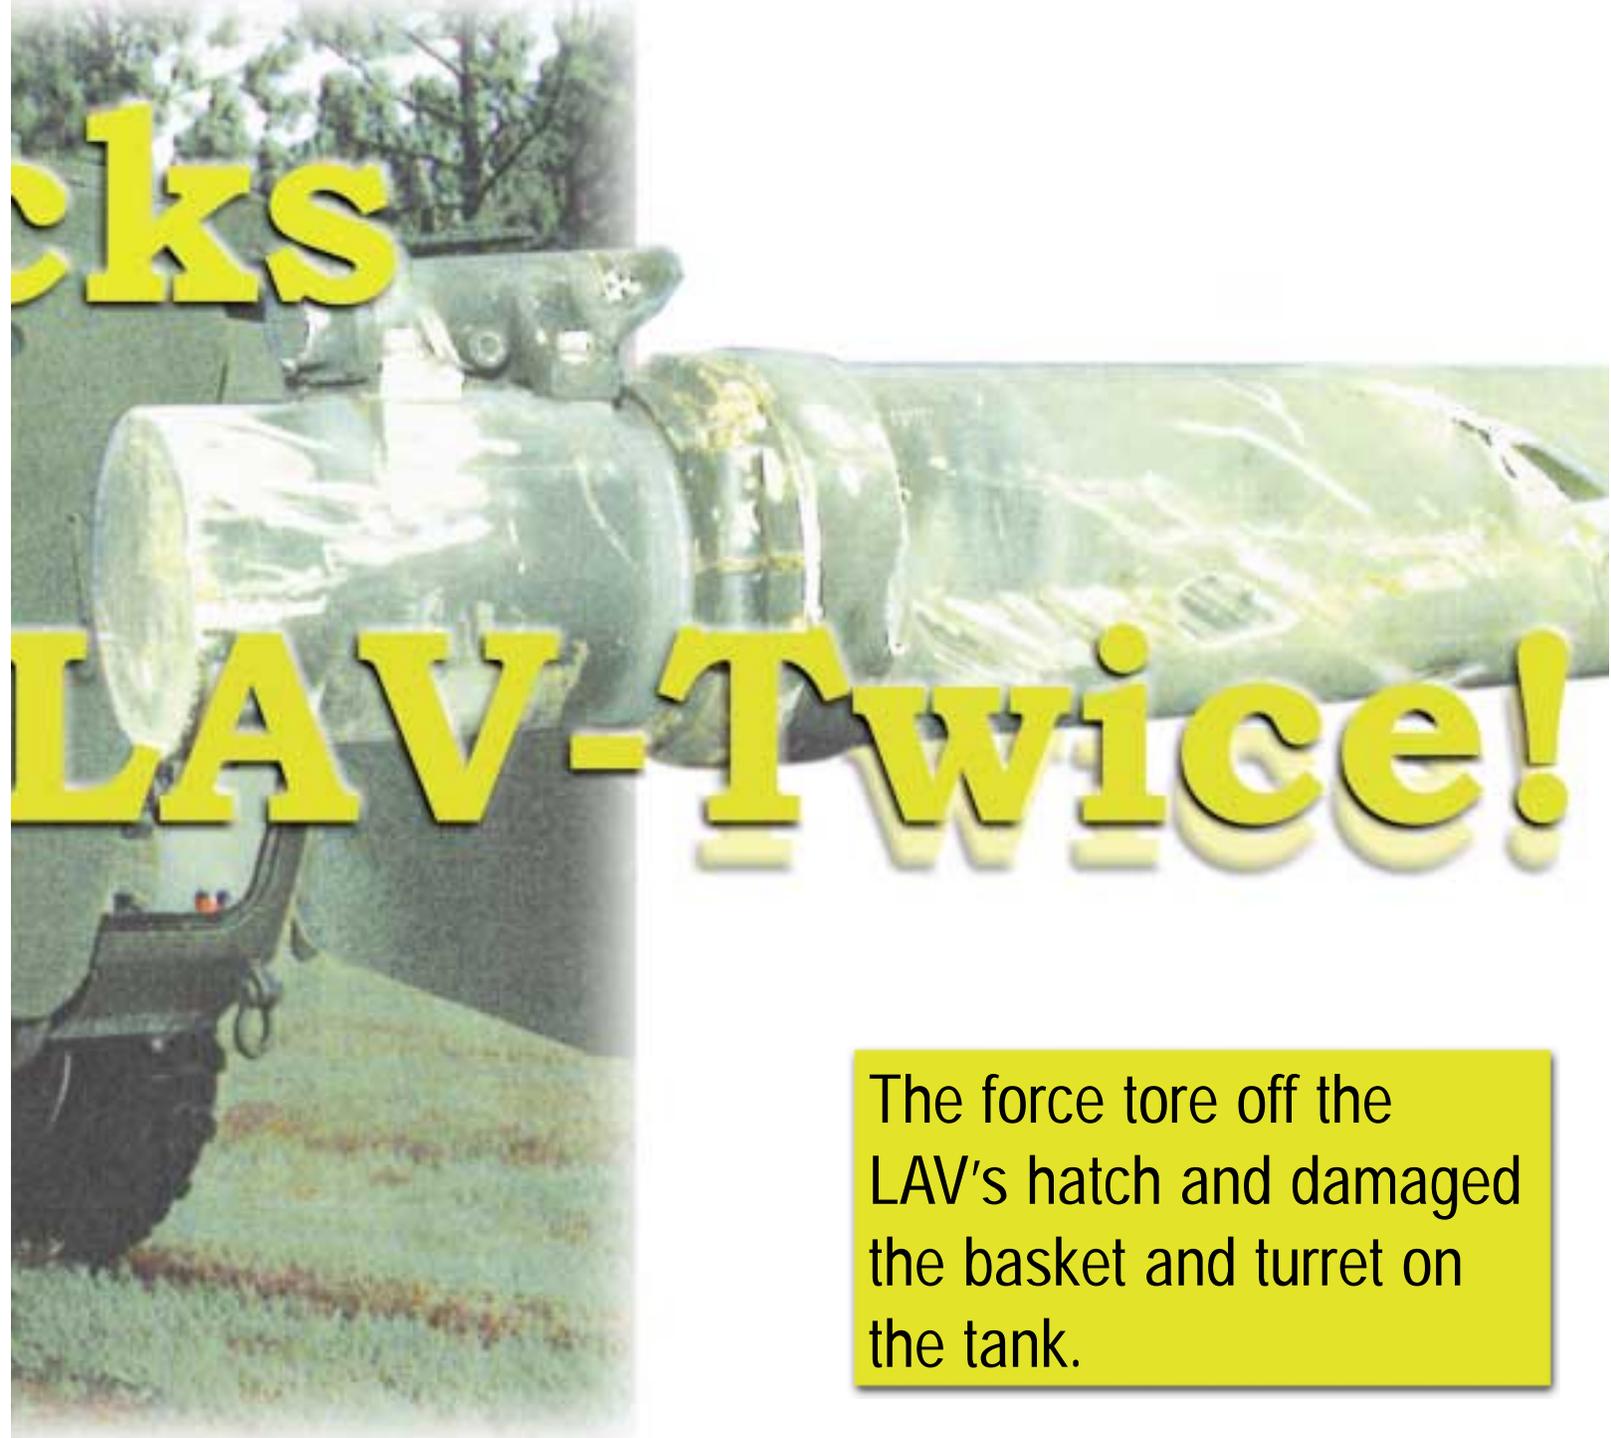
The force tore off the LAV's hatch and damaged the basket and turret on the tank.

Remember the LAV that was parked just off the pavement in front of the bleachers? Well, it wasn't parked quite far enough off. As the tank rumbled in front of the stands containing the governor's committee for military affairs, the gun's muzzle smashed into the LAV's left rear loading hatch and turret. The force tore off the hatch and damaged the tank's basket and turret.

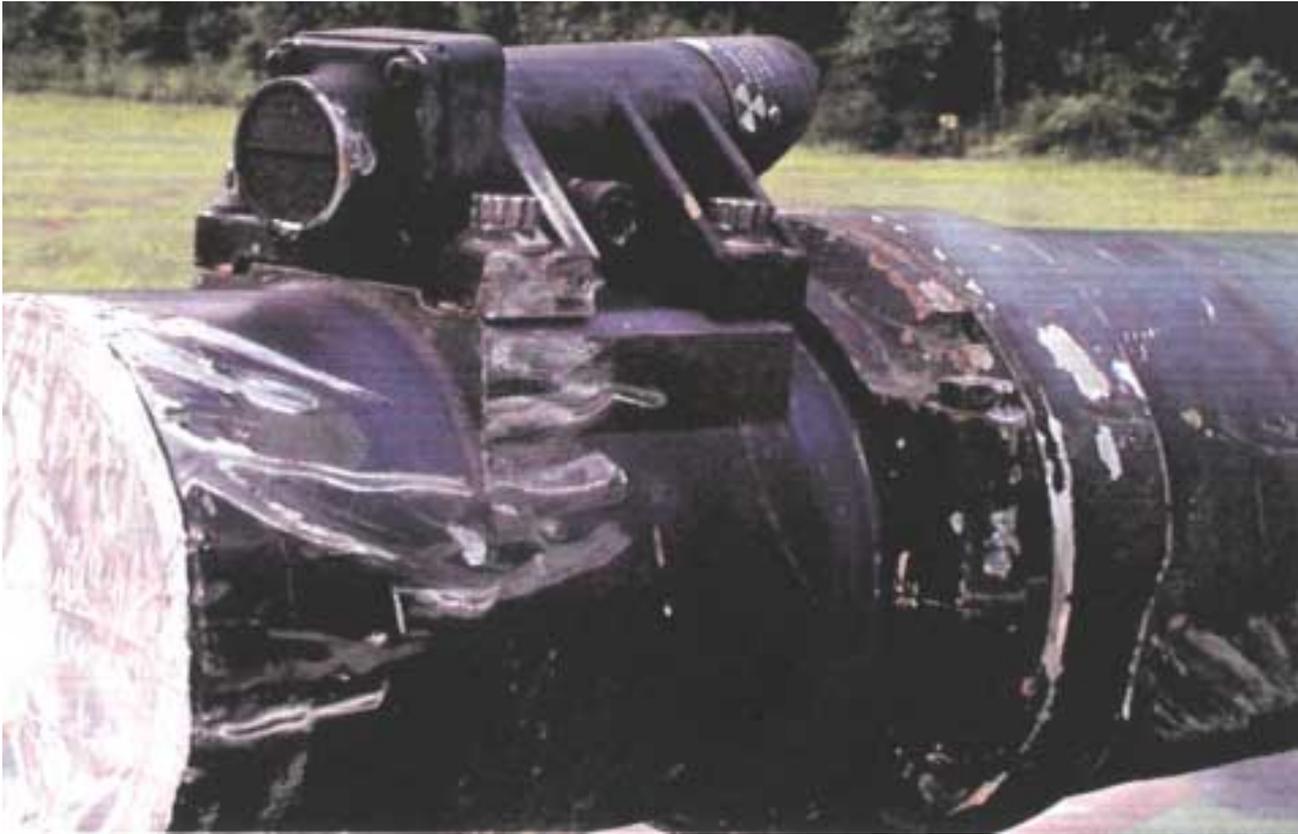
As the tank began its second lap, the driver accelerated to 35 mph. The main gun again acquired its target as the Abrams drove over the speed bumps and came around for its second pass. Once again, the muzzle swung out to a 90-degree angle. This time, it slammed into the LAV 2 feet lower. The force shoved the LAV 4 feet forward and to the right, dented the hull, damaged the tail light, and chipped some paint.

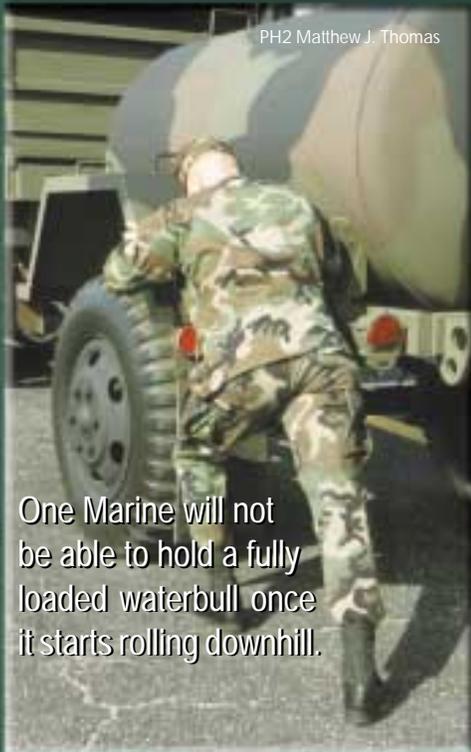
One Marine will not be able to hold a fully loaded waterbull once it starts rolling downhill.

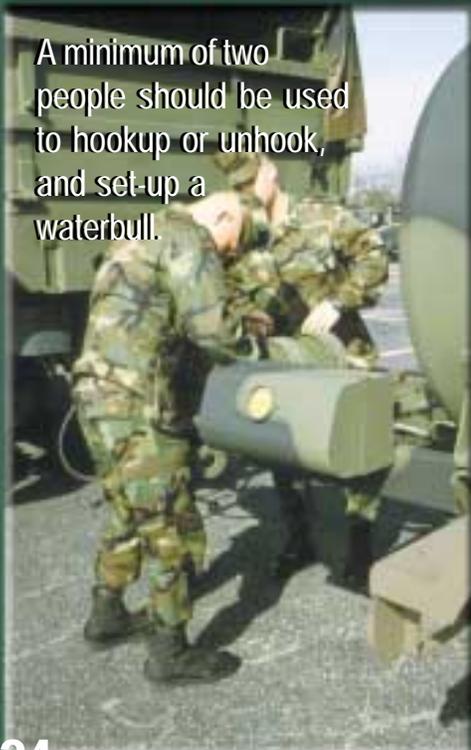
A minimum of two people should be used to hookup or unhook, and set-up a waterbull.

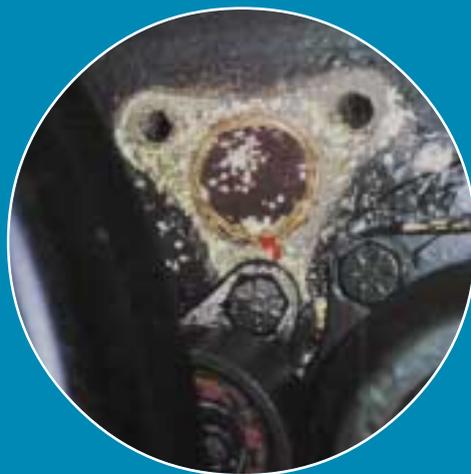
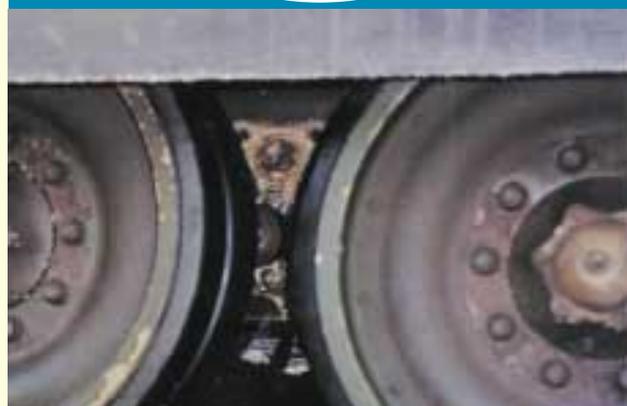
The holes may be small, but the amount of water they let in wasn't.

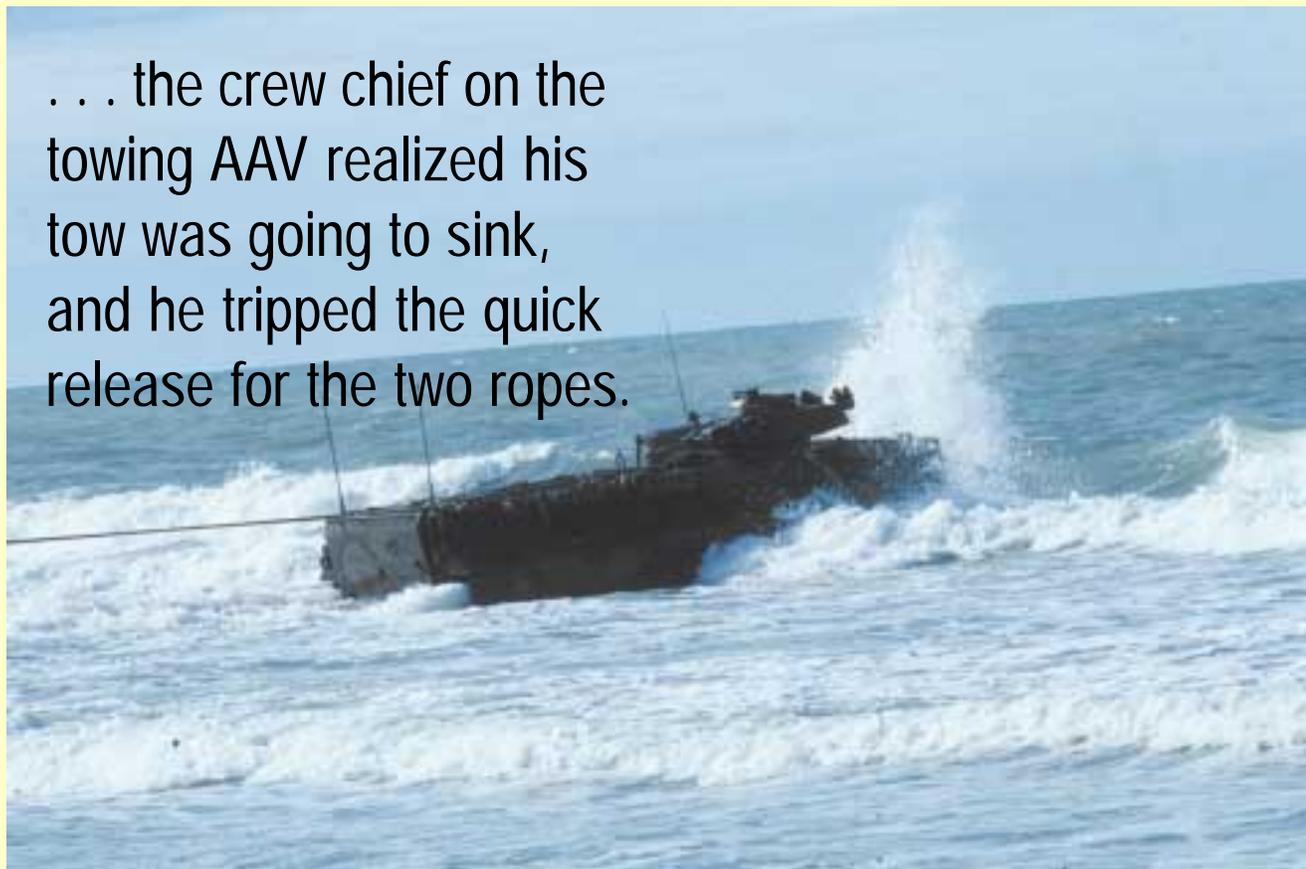
. . . the crew chief on the towing AAV realized his tow was going to sink, and he tripped the quick release for the two ropes.

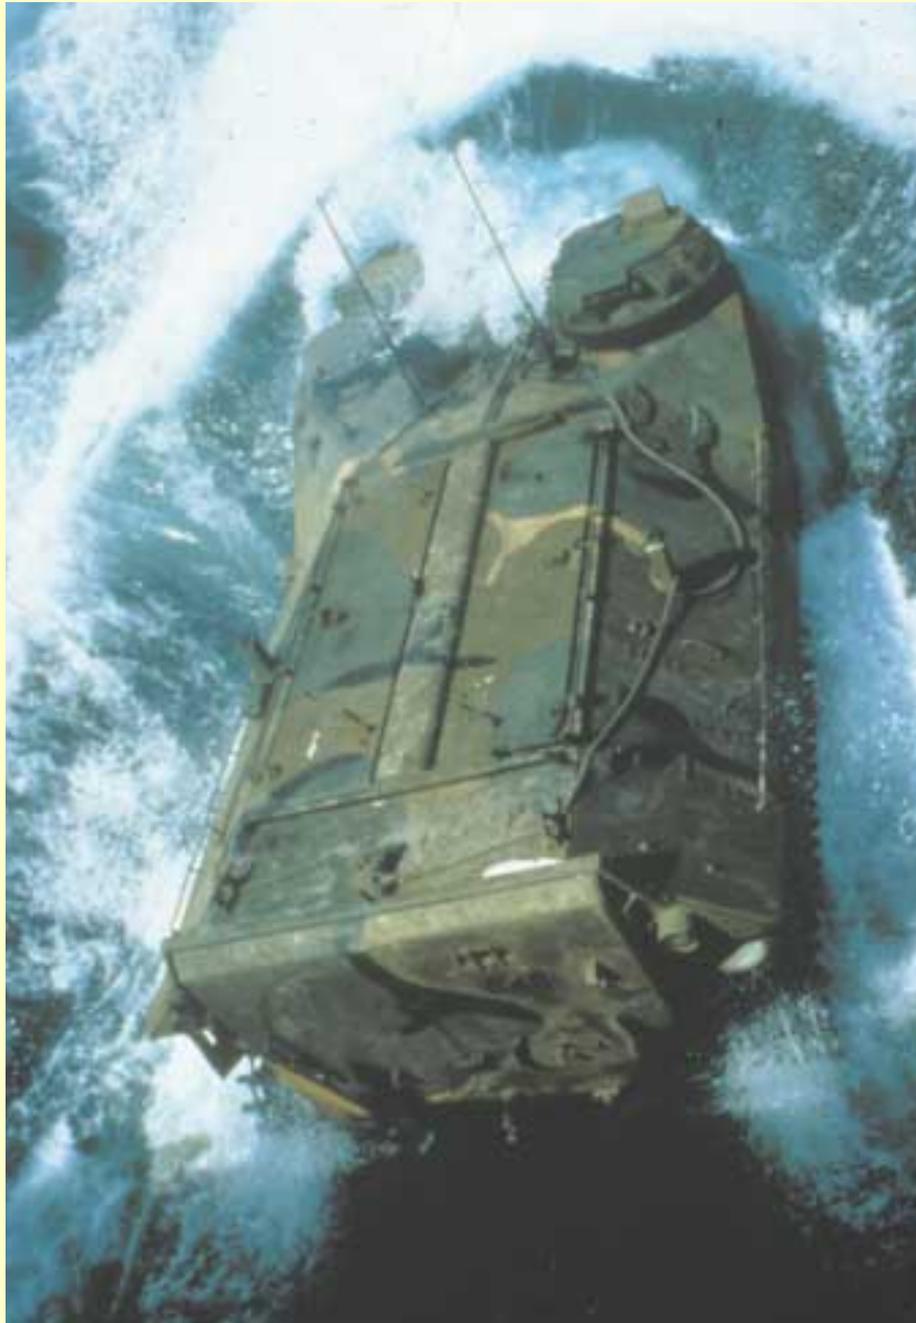
Thirty minutes after the AAV under tow lost electrical power, two large swells hit it. The rocking motion sent all the water in the AAV rushing into the bow, tilting it down 75 degrees. The towing AAV immediately stopped, and the crew chief called the safety boat to tell them that the towed AAV was sinking. The platoon commander called the towing AAV to pass the word to the crew to get off the sinking vehicle.

The AAV hit two big swells, tilted 75 degrees, and plunged straight to the bottom.

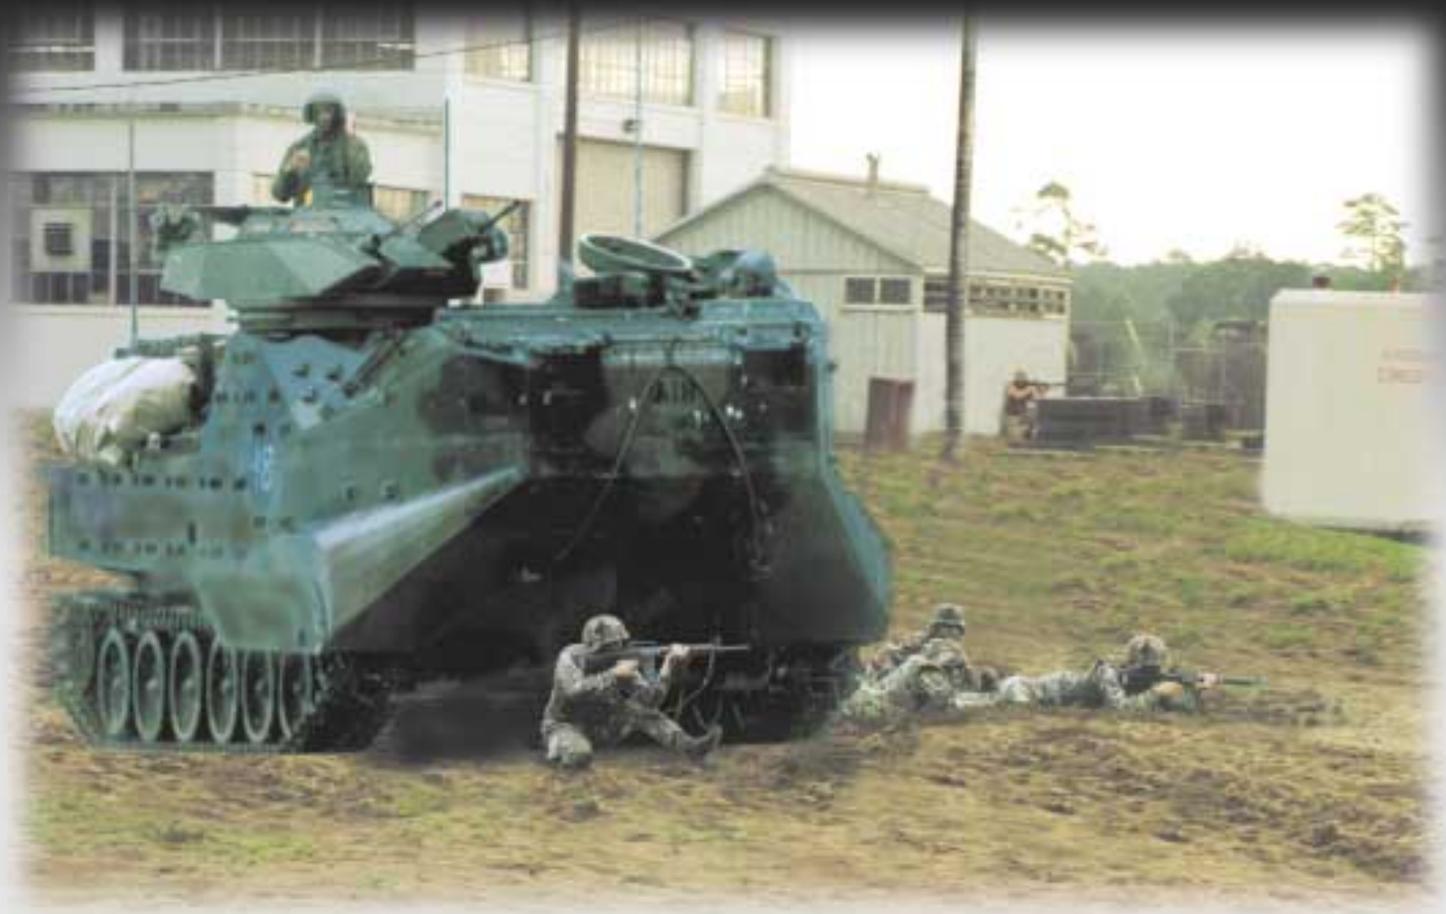
A danger zone surrounds an amphibious assault vehicle (AAV). When the driver and the crew chief are sitting in their seats, they have a blind spot surrounding the immediate front of the vehicle. A ground guide must give directions to the driver before he moves the AAV.
