# A Shocking Revelation

## Cranial On and Chin Strap Buckled

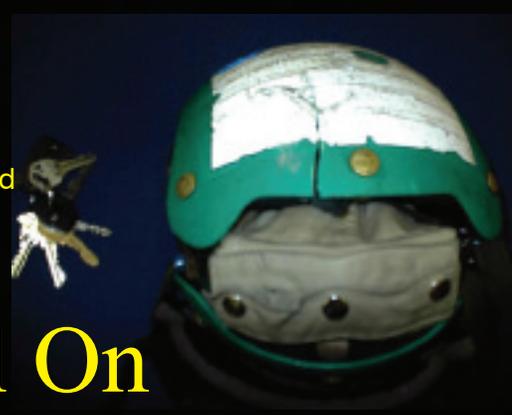
This cracked cranial saved a life. Can you imagine the injury had this maintainer not worn it?

A plane captain on weekend duty was doing routine maintenance on the forward rotor head of a UH-46D in the hangar. While safety wiring a shock absorber, she banged her elbow and lost consciousness from the pain. She fell off the work platform and landed headfirst on the cement, 14 feet below. The airman's cranial was her sole line of defense.

The good news is she wore PPE. That fact, and the quick reaction of shipmates, allowed for successful neck surgery. The airman was back at work in Guam a mere three weeks later. The proper use of a fastened cranial protected a shipmate from what easily could have been a paralyzing or life-threatening injury.
