Tail Rotor Meets Hangar Door

By AD3 Benjamin Nelson

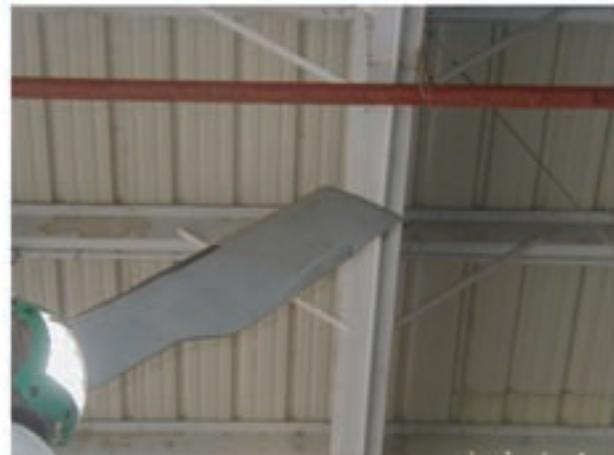
We almost were inside the hangar when I heard a pop. At first, I thought it was the tow bar because the tractor was on a slight incline. That's when the PC and I looked up at the tail rotor, and our mouths dropped. I blew the whistle to stop the move, and everyone froze. We quickly backed up the aircraft and examined the tail. One of the tail-rotor blades had a two-and-a-half-inch tear.

The blade that caused it doesn't look bad from a distance.

This mistake reminded us that even the most routine tasks can go bad when situational awareness is lost. It just was a momentary slip but cost the squadron thousands of dollars. We received a harsh reminder that the move brief is the time and place to identify all the hazards associated with moving an aircraft. A lax attitude during a routine job is one thing that can ruin the day and damage an aircraft.

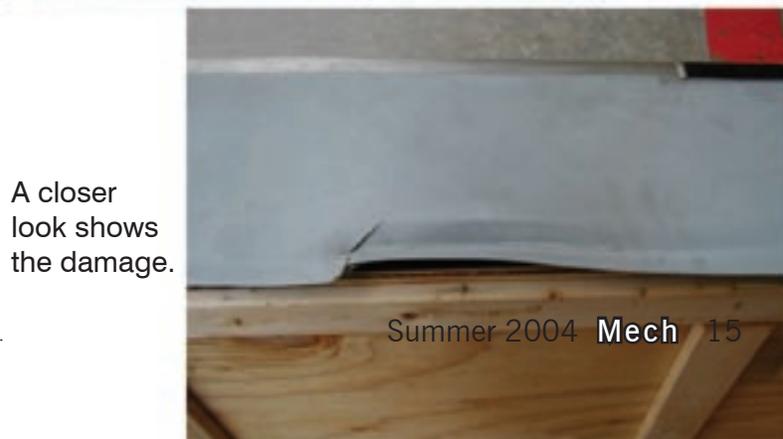
A closer look shows the damage.
